CLIENT:
Biform Ltd.
PO Box 13842
Onehunga, Auckland 1643

SAMPLE DESCRIPTION:
Flooring Planks – Biform SPC Rigid Flooring.

RESILIENT FLOOR COVERINGS (BASED ON ISO 4760:2022(E) - LAMINATE FLOORING – TOPICAL MOISTURE RESISTANCE – ASSEMBLED JOINT (MODIFIED))

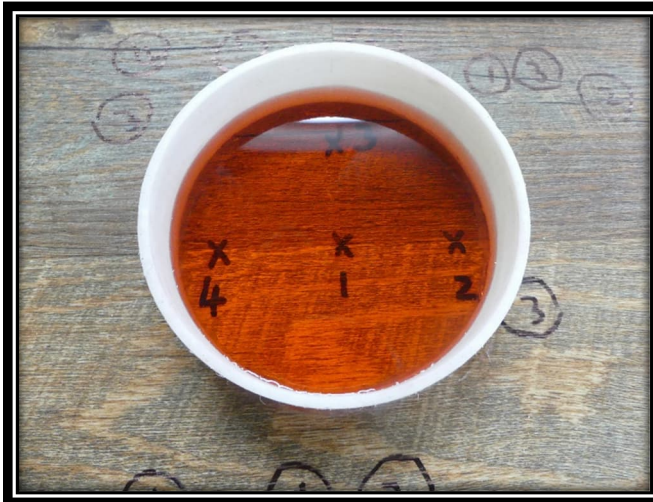
After 24 hrs With Water

100 mls of dye solution was applied onto the sample surface. It was poured into a cylinder 100mm diameter placed in the centre of the sample at the "T joint." Sealant was used at the plank/cylinder interface to avoid leakage.

Observations:	Specimen 1	Specimen 2	Specimen 3
Migration of water along the upper surface:	No	No	No
Migration of water to the underside:	No	No	No

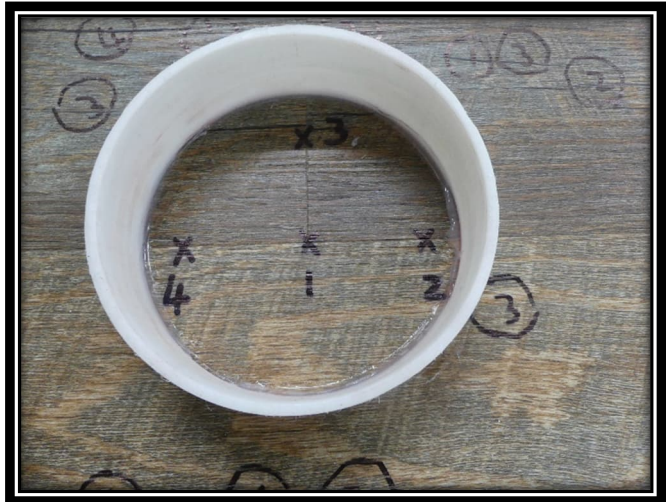
Wet Swell

Quantitative Results:	Wet Swell (mm)			Recovered Swell (mm)		
	Specimen 1	Specimen 2	Specimen 3	Specimen 1	Specimen 2	Specimen 3
Final Average Results (Positions 2 to 4)	0.01	0.04	0.01	0.00	0.00	0.00
Final Results (Position 1)	0.06	0.04	0.00	0.00	0.02	0.00

Wet Swell			Recovered Swell		
	Specimen 1	Specimen 2	Specimen 3	Specimen 1	Specimen 2	Specimen 3
Qualitative Ratings (individual results):	1	1	1	1	1	1

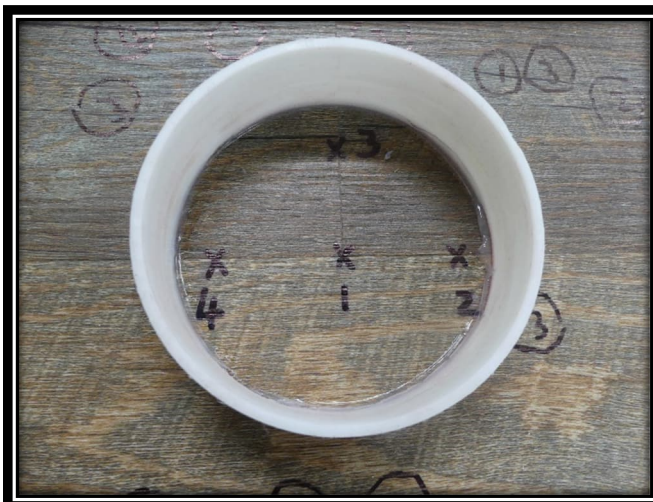
Recovered Swell

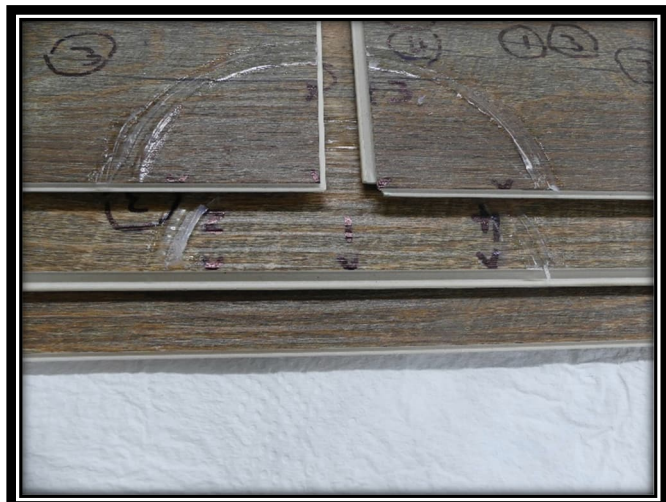
Recovered Swell (Disassembled)

Disassembly Observations:	Specimen 1	Specimen 2	Specimen 3
Migration of water along the upper surface:	No	No	No
Migration of water to the underside:	No	No	No
